15 YEARS LATER: ON THE PHYSICS OF HIGH-RISE BUILDING COLLAPSES

■ Steven Jones¹, Robert Korol², Anthony Szamboti³ and Ted Walter⁴

■ ¹Brigham Young University (early retired) – ²McMaster University (emeritus) – ³Mechanical design engineer in the aerospace industry – ⁴Architects & Engineers for 9/11 Truth – DOI: <http://dx.doi.org/10.1051/eprn/2016402>

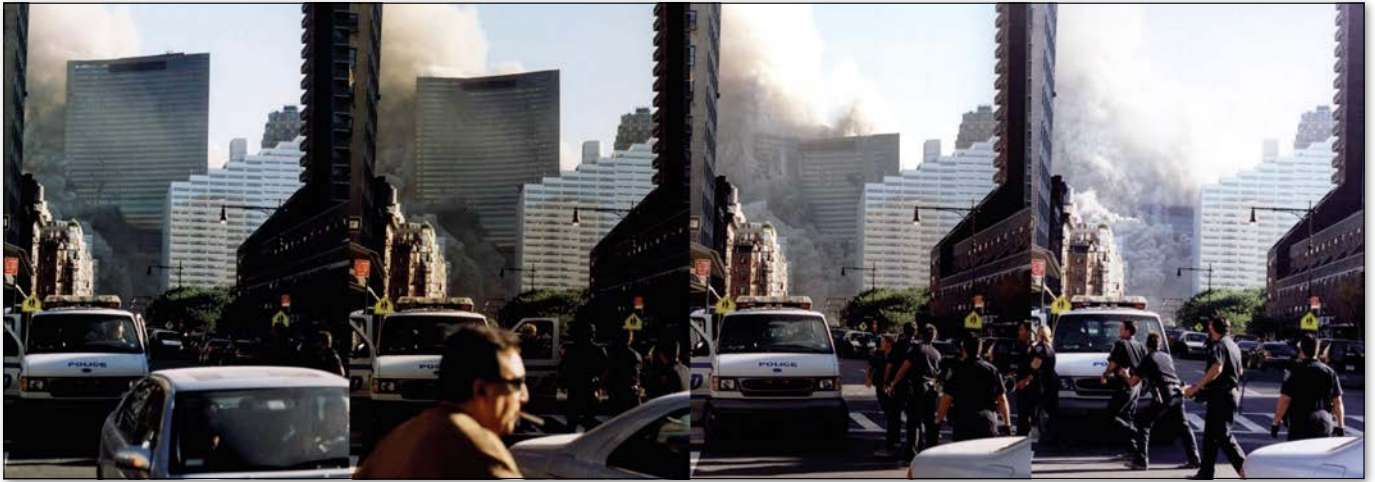
▼ FIG. 1: WTC 5 is an example of how steel-framed high-rises typically perform in large fires. It burned for over eight hours on September 11, 2001, and did not suffer a total collapse (Source: FEMA).

Throughout history, three steel-framed high-rises are known to have suffered partial collapses due to fires; none of those led to a total collapse. Countless other steel-framed high-rises have experienced large, long-lasting fires without suffering either partial or total collapse (see, for example, Fig. 1a and 1b) [1].

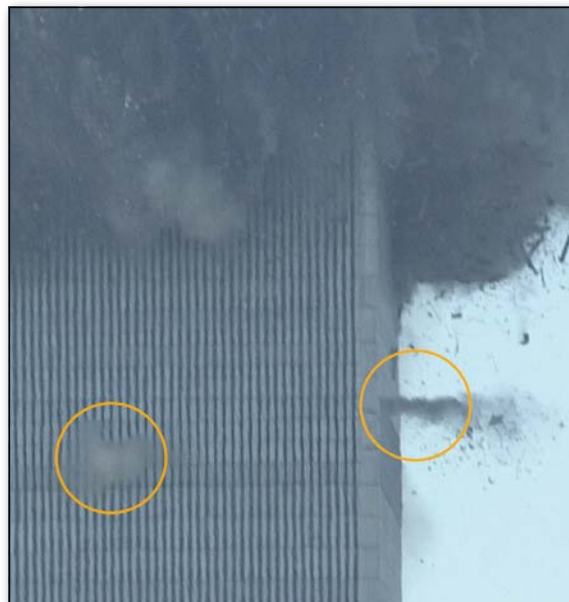
◀ FIG. 5: High-velocity bursts of debris, or “squibs,” were ejected from point-like sources in WTC 1 and WTC 2, as many as 20 to 30 stories below the collapse front (Source: Noah K. Murray).

The collapse mechanics discussed above are only a fraction of the available evidence indicating that the airplane impacts and ensuing fires did not cause the collapse of the Twin Towers. Videos show that the upper section of each tower disintegrated within the first four seconds of collapse. After that point, not a single video shows the upper sections that purportedly descended all the way to the ground before being crushed. Videos and photographs also show numerous high-velocity bursts of debris being ejected from point-like sources (see Fig. 5). NIST refers to these as “puffs of smoke” but fails to properly analyze them [6]. NIST also provides no explanation for the midair pulverization of most of the towers’ concrete, the near-total dismemberment of their steel frames, or the ejection of those materials up to 150 meters in all directions.

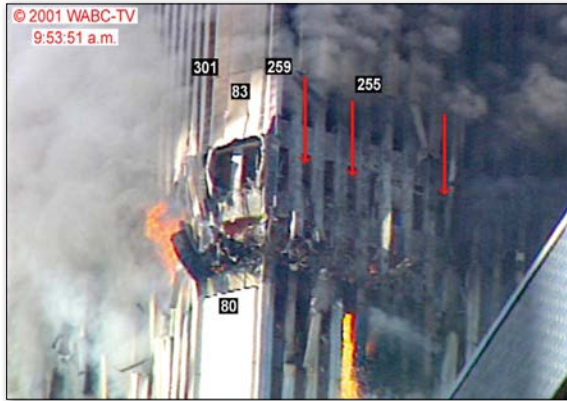
► **FIG. 6:** Molten metal was seen pouring out of WTC 2 continuously for the seven minutes leading up to its collapse (Sources: WABC-TV, NIST).

NIST sidesteps the well-documented presence of molten metal throughout the debris field and asserts that the orange molten metal seen pouring out of WTC 2 for the seven minutes before its collapse was aluminum from the aircraft combined with organic materials (see Fig. 6) [6]. Yet experiments have shown that molten aluminum, even when mixed with organic materials, has a silvery appearance—thus suggesting that the orange molten metal was instead emanating from a thermite reaction being used to weaken the structure [12]. Meanwhile, unreacted nano-thermitic material has since been discovered in multiple independent WTC dust samples [13].
